AERIAL PHOTOGRAPHIC ANALYSIS OF SELECTED HAZARDOUS WASTE STUDY SITES

New Mexico and Texas

EPA Region VI

TS-AMD-82110a
April 1983

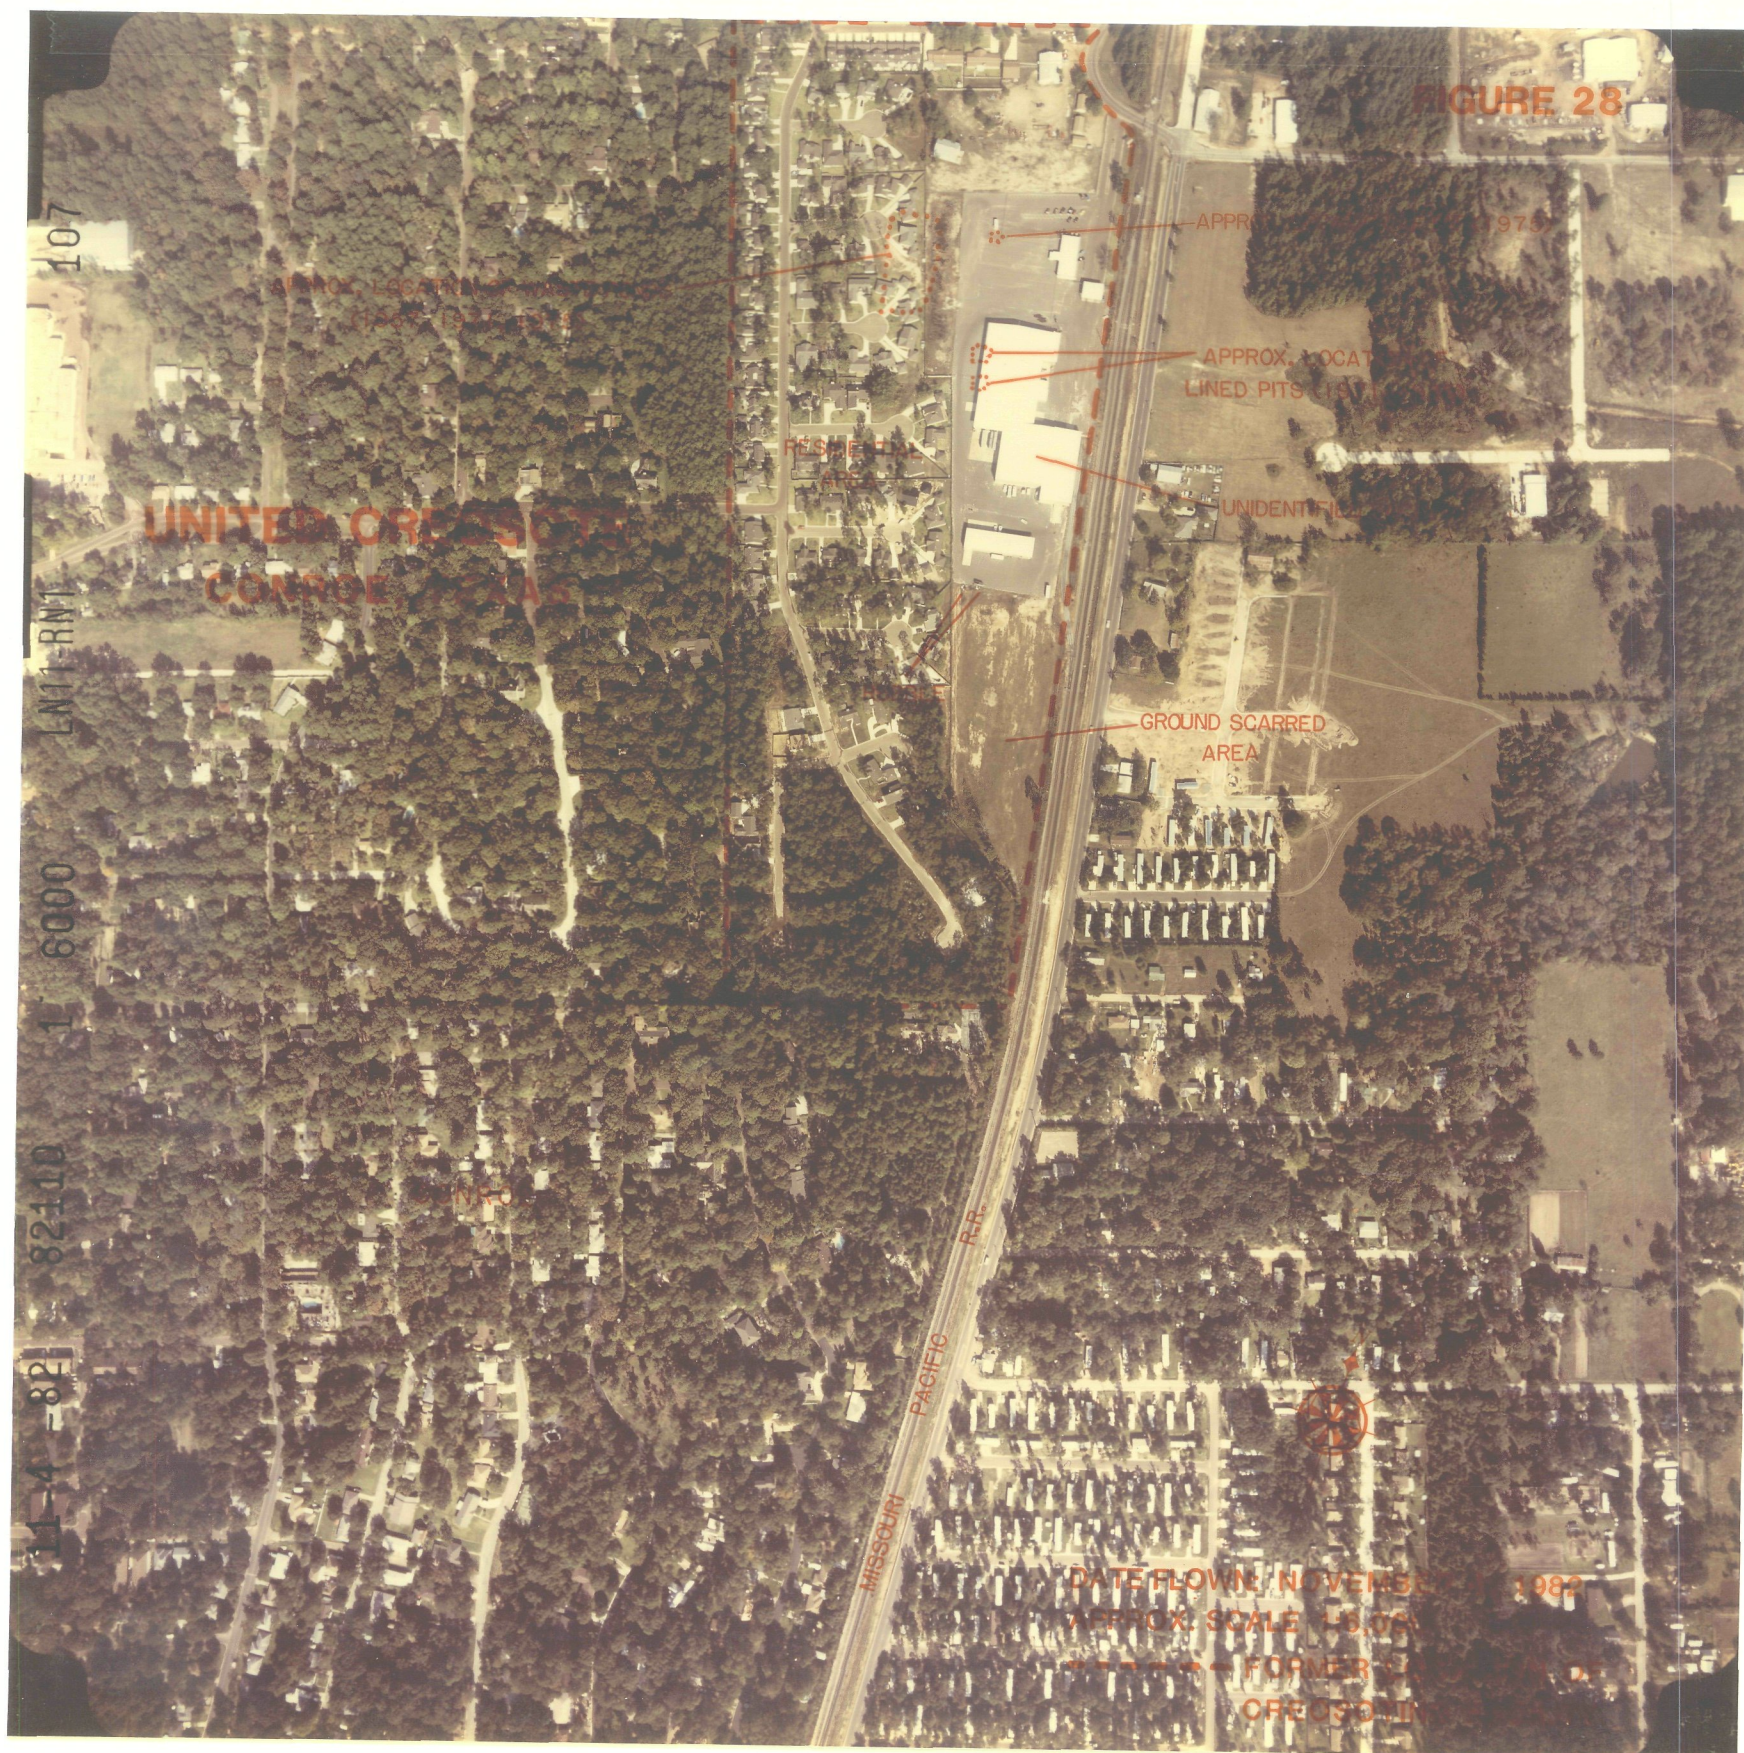
The property upon which United Creosote was formerly located appears much the same as it did on the 1980 photograph (Figure 28). The scarred area appears more moist than it did on the earlier photograph (Figure 27), a factor that may be attributed to seasonal rainfall. Two piles of rubble are noted at the juncture of the scarred field and paved area.

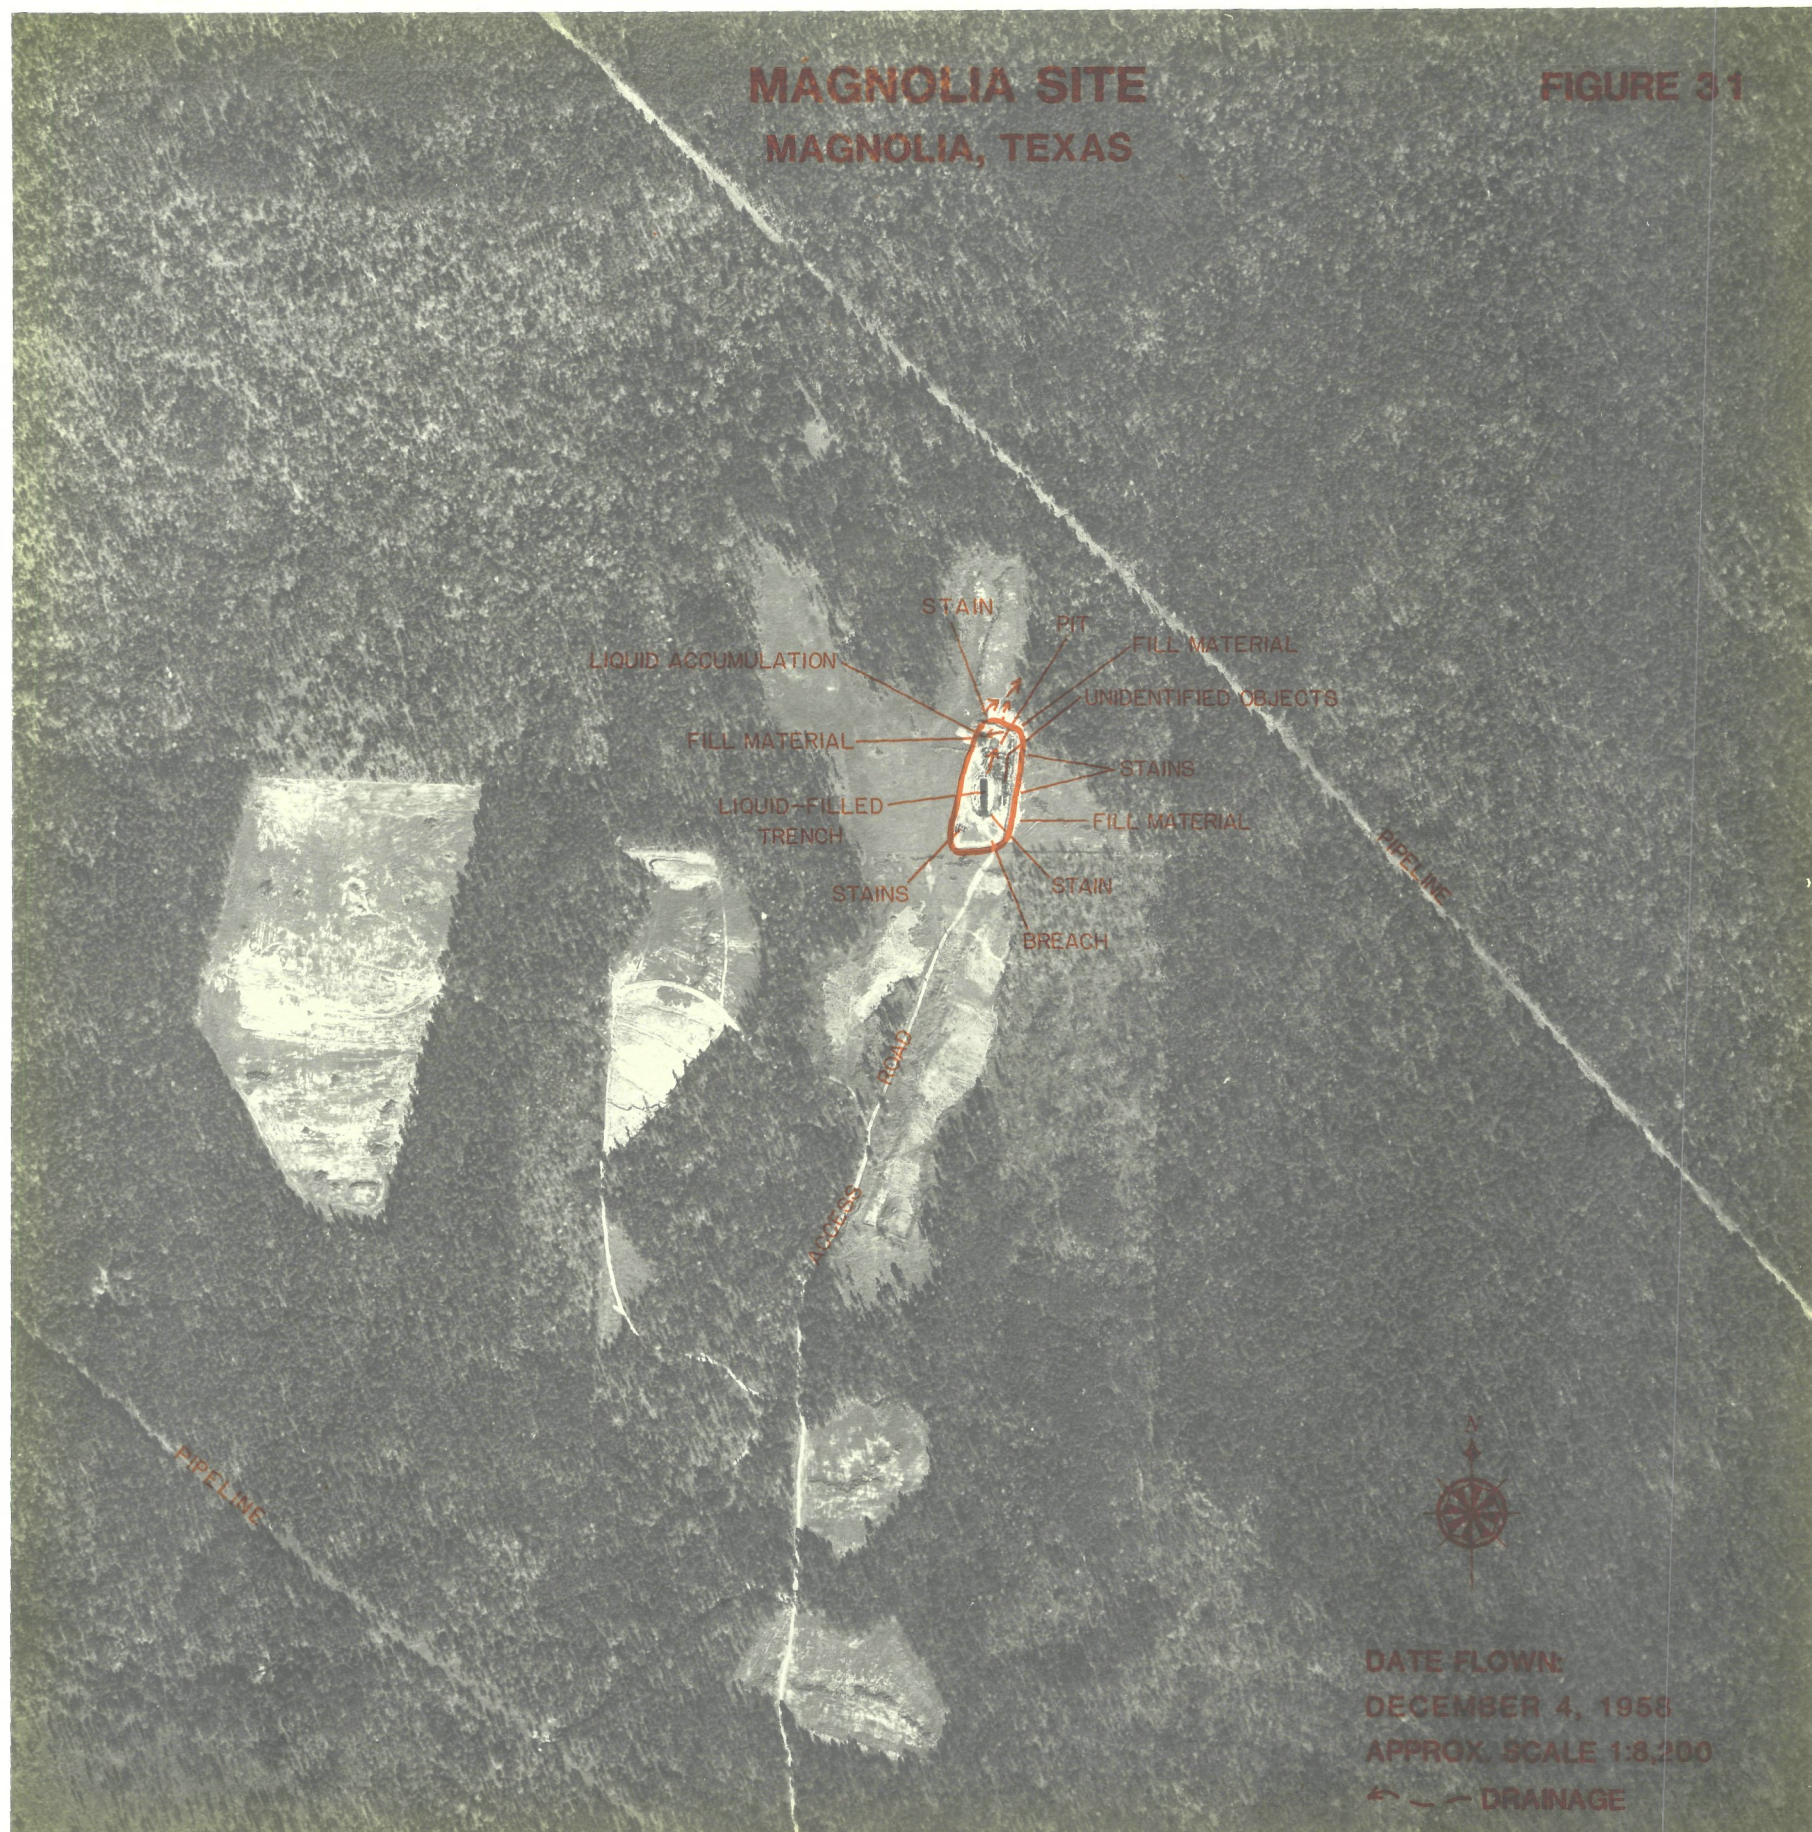
FIGURE 31

A waste disposal area (Figure 31) is visible within a clearing that was previously noted on the 1952 photograph. A soil buildup that surrounds the disposal area has been breached in order to allow vehicular access to the site. Stains and fill material that are visible outside the built-up area suggest that waste materials may have flowed off the site.

A large liquid-filled trench and a horseshoe-shaped pit are present within the site. Stains visible at the southern end of the trench suggest spillage and/or overflow of the contents within the trench. Additional stains are noted within the horseshoe-shaped pit and amid a gathering of unidentified objects which are also present at the site. An accumulation of liquid is also visible.

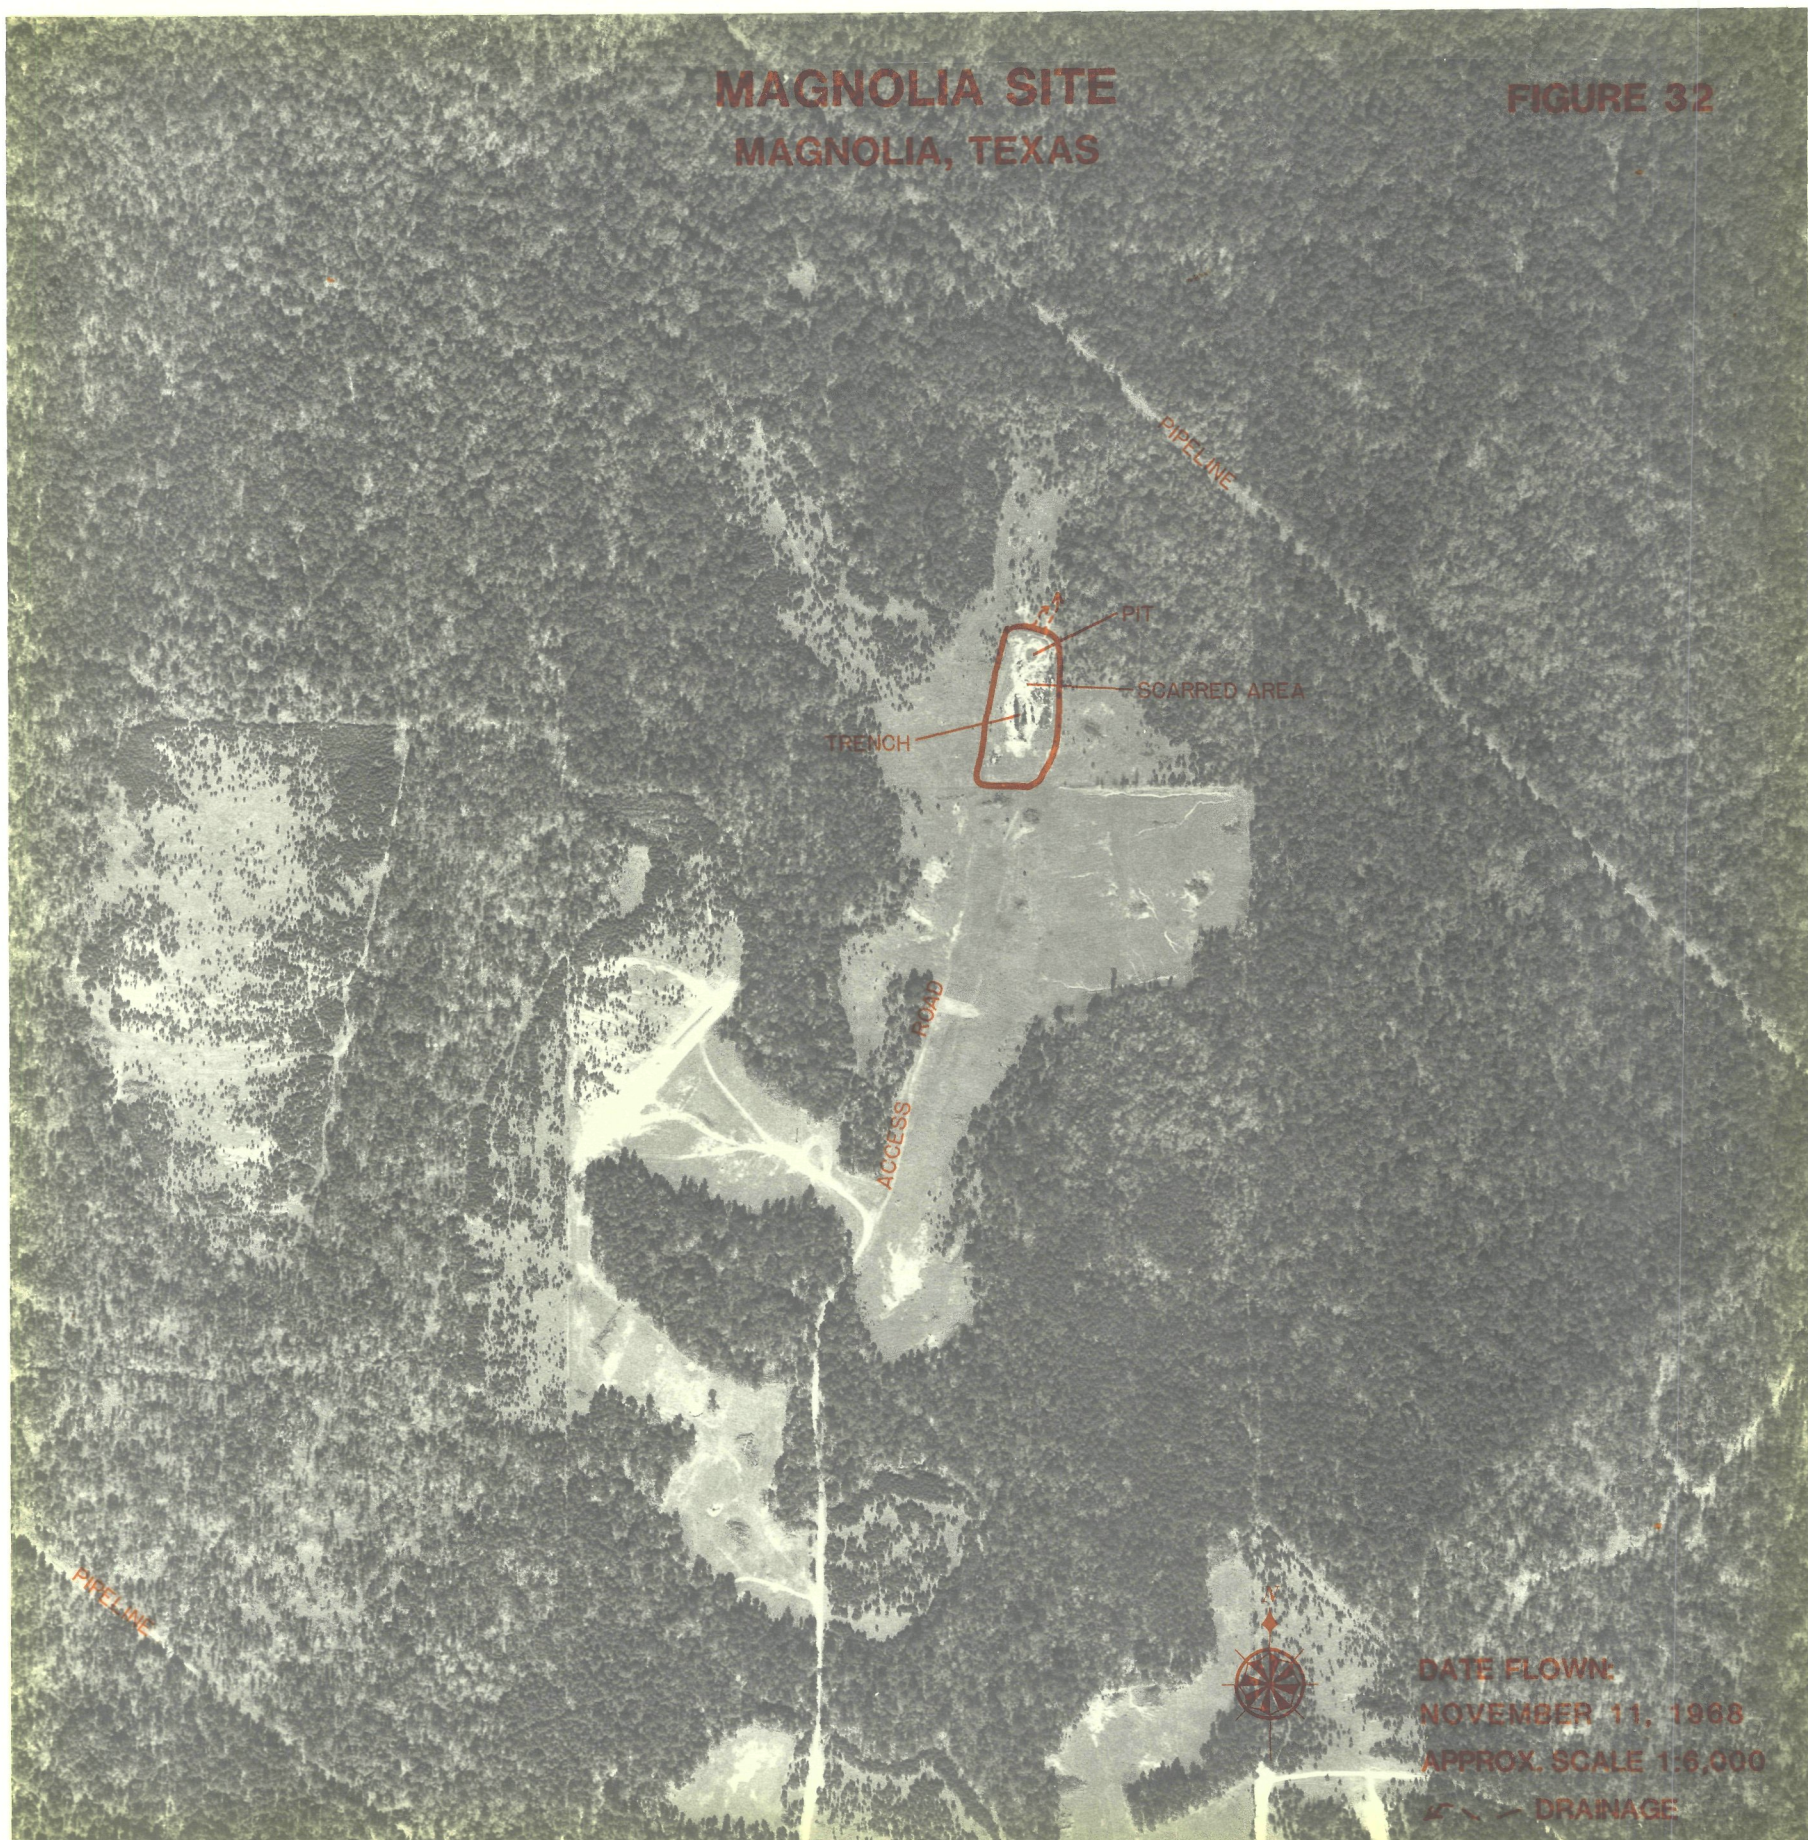
FIGURE 32

Much of the access road that leads into the disposal area has become overgrown with vegetation, indicating a possible lack of use (Figure 32). The liquid-filled trench that was noted on the December 1958 photograph (Figure 31) has been drained. Considerable scarring is visible within areas that are adjacent to the trench. The horseshoe-shaped pit visible on the 1958 photograph has been fully bermed into a circular shape. The center of the bermed area appears stained.

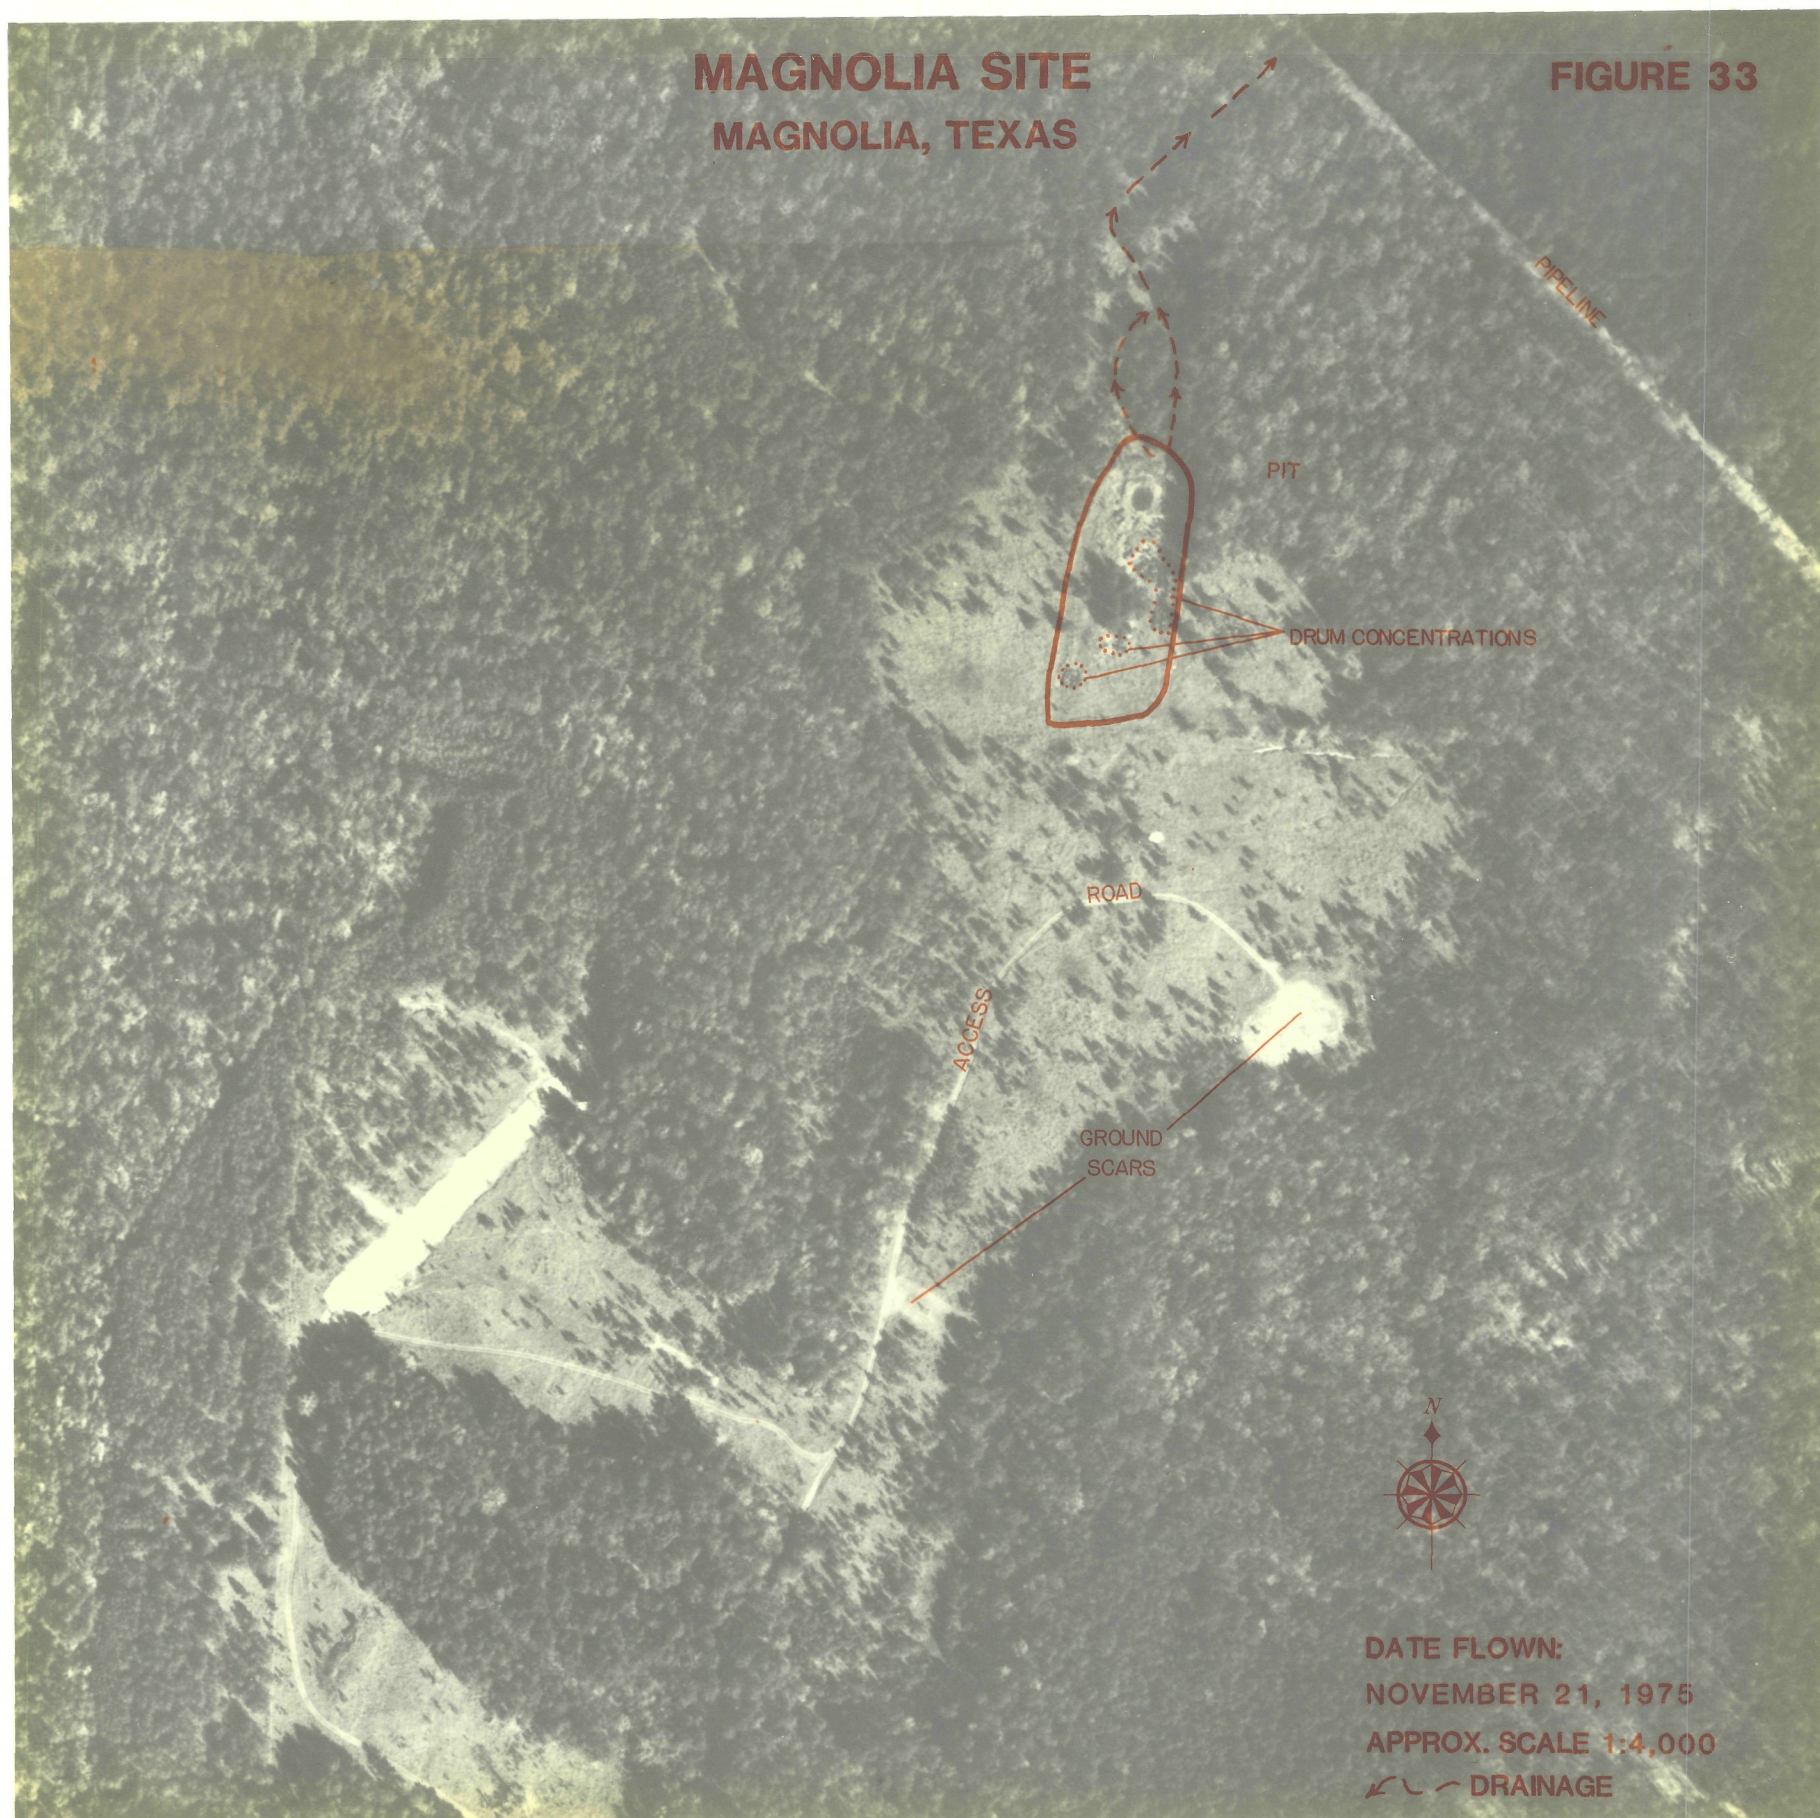
FIGURE 33

Approximately 100-150 objects that appear to be drums have been discarded within the site (Figure 33). No leakages or spillages are noted.

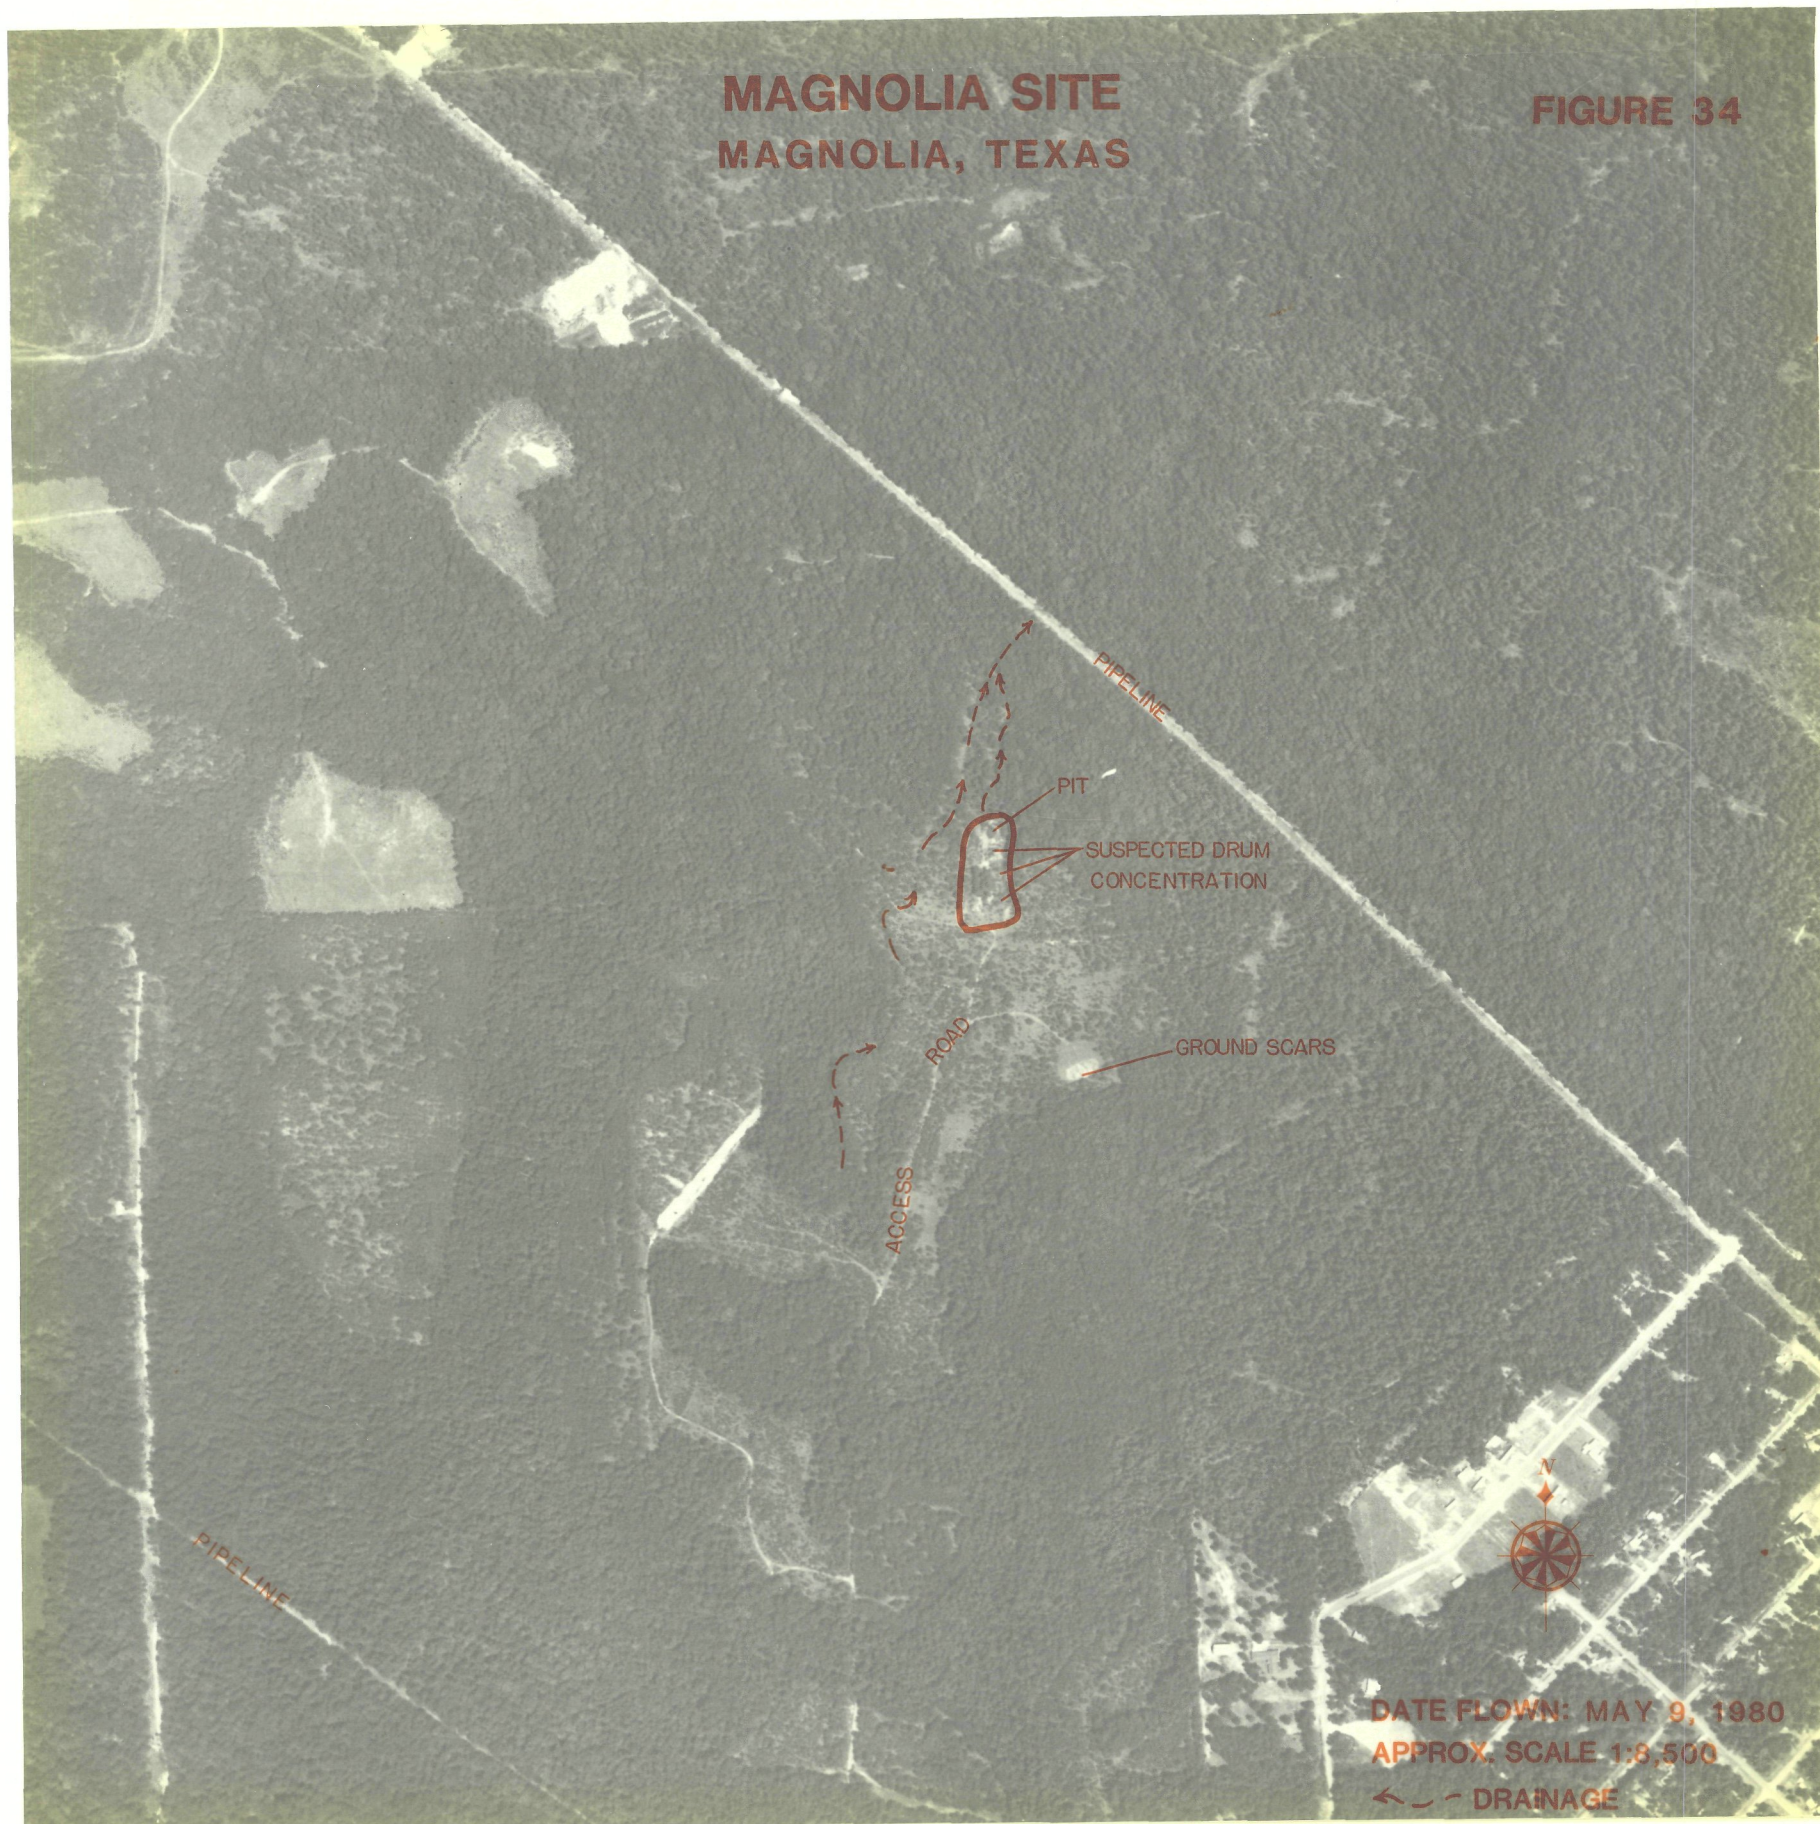
FIGURE 34

The drum site appears much the same (Figure 34) as it did during November 1975. Objects which may be drums are again noted; however, the scale and quality of this photograph hinder further analysis of the suspected drums.

One of two heavily scarred areas that were noted along the site access road on the 1975 photograph (Figure 33) has been completely overgrown with vegetation. Some scars remain visible at the second area, but it too is returning to its vegetative state.

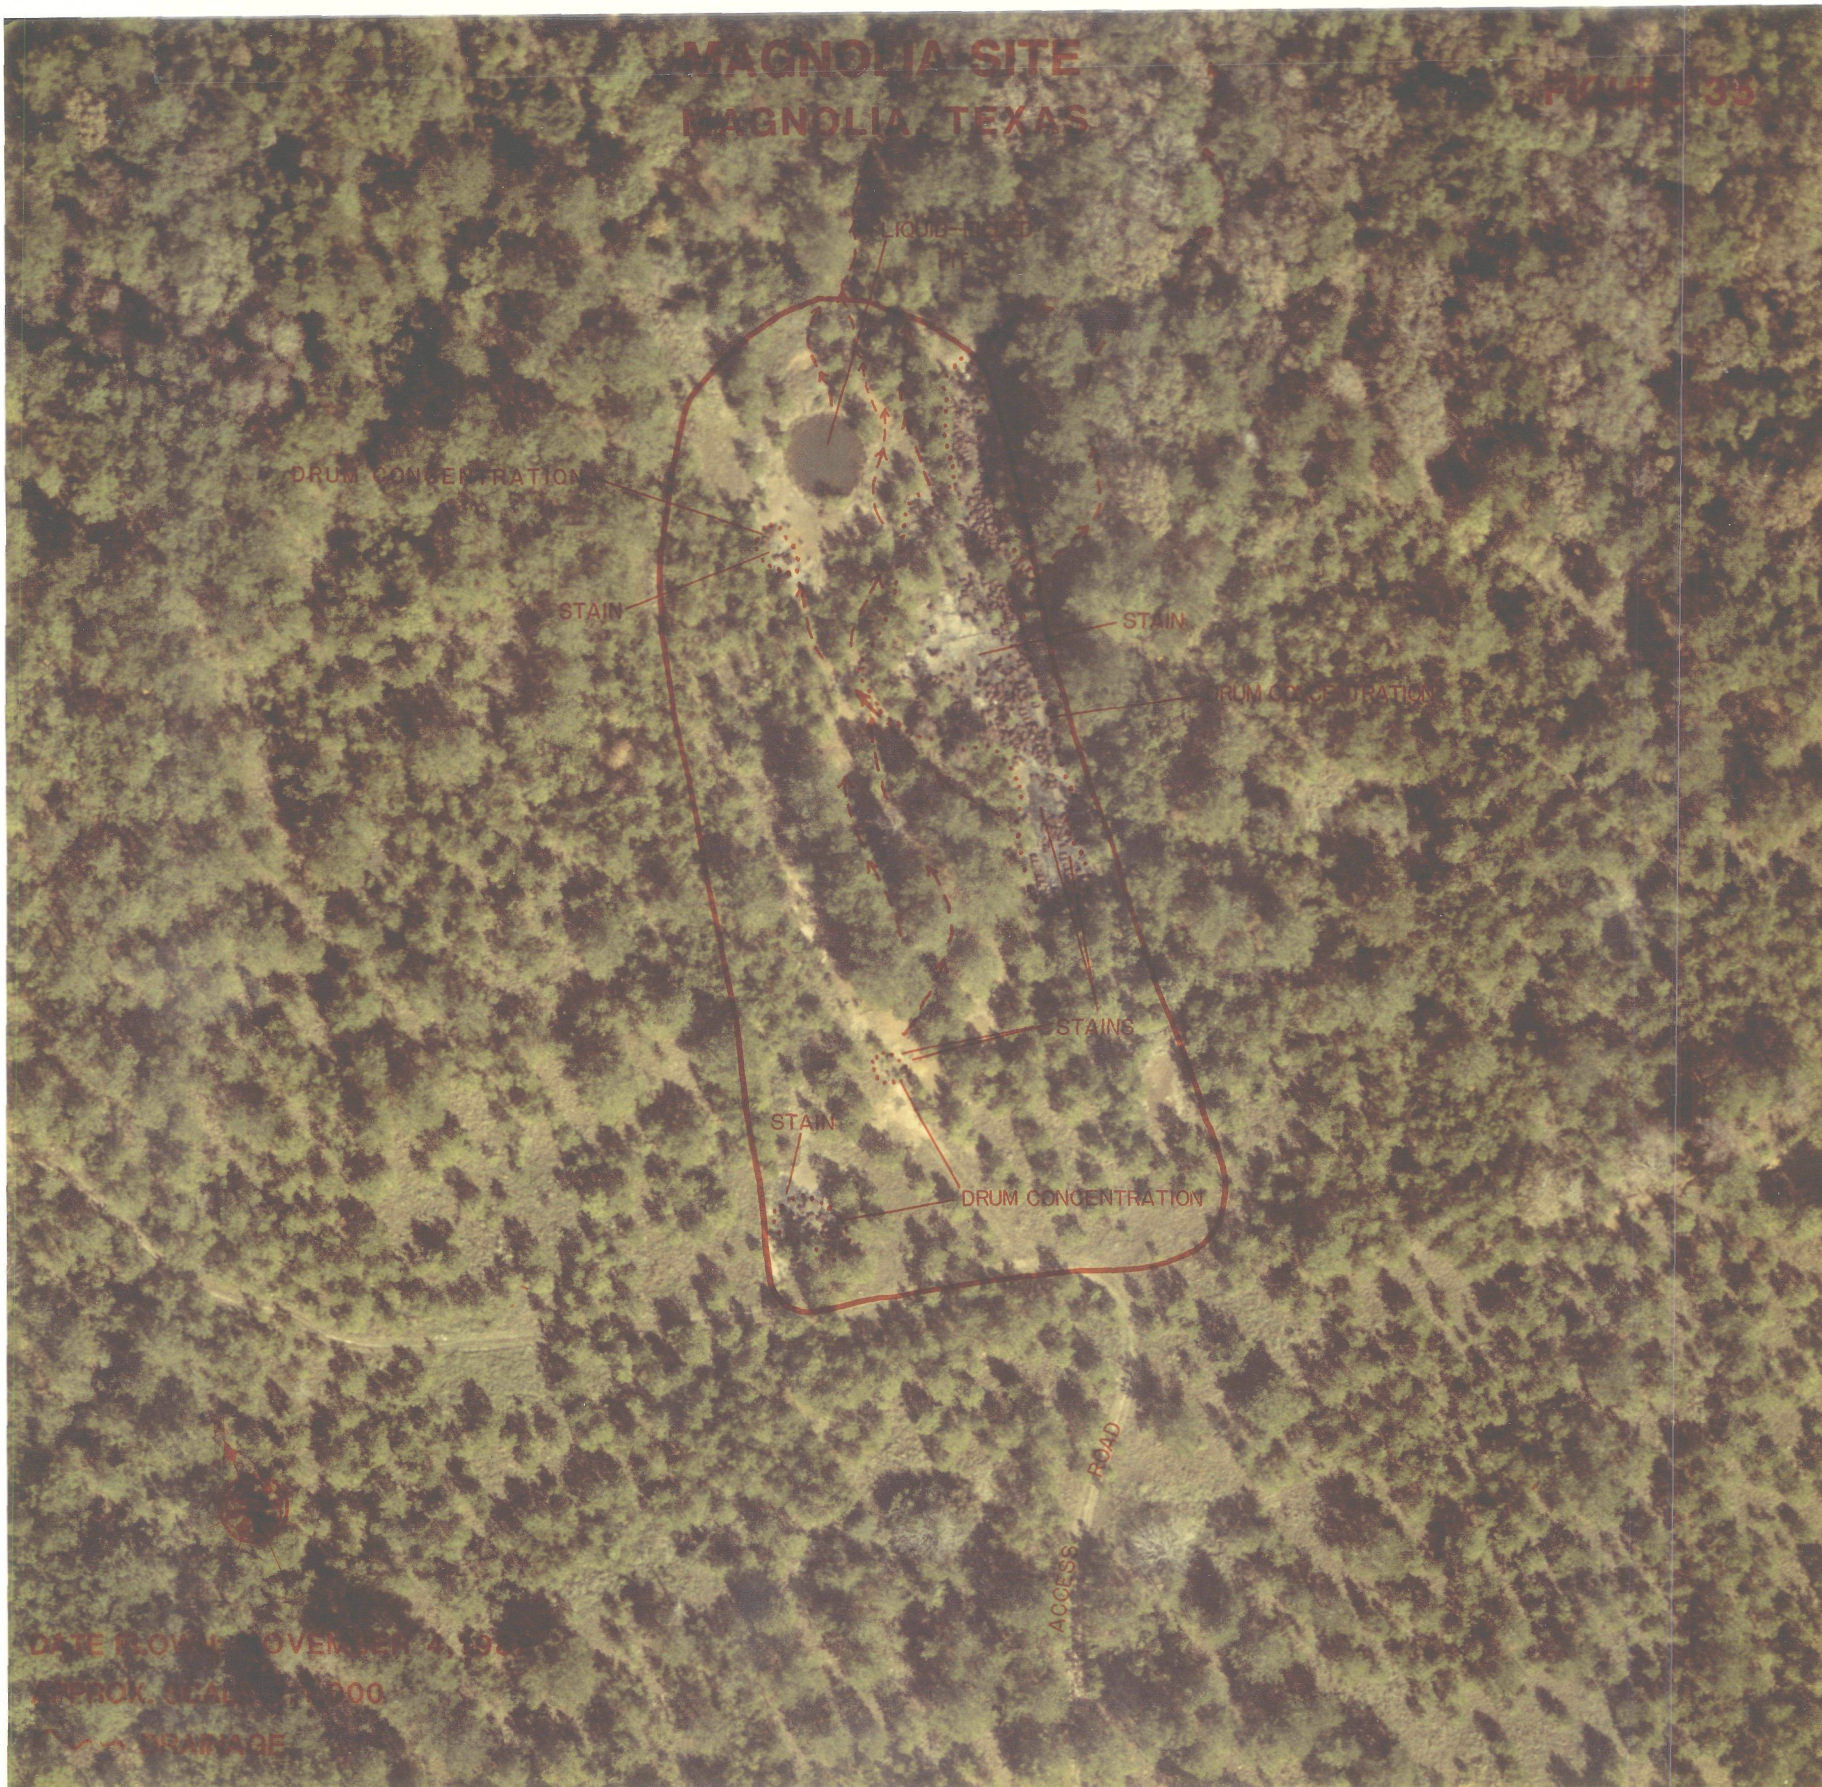
Approximately 150-200 drums appear to have been discarded within the disposal area (Figure 35). Stains visible in the vicinity of the drums suggest that some of the contents of the containers may be seeping out. Contaminants do not appear to have entered surface drainages. Liquid contained within an old pit that has been visible since December 4, 1958 (Figure 31), may be rainwater.
